SUBJECT: Transmittal Memo – Compliance Monitoring Report

FACILITY NAME: Louisiana Land and Water Company, Inc.
Woodland Acres STP #2

NPDES Compliance Inspection Report

LPDES Permit Number: LAG540021

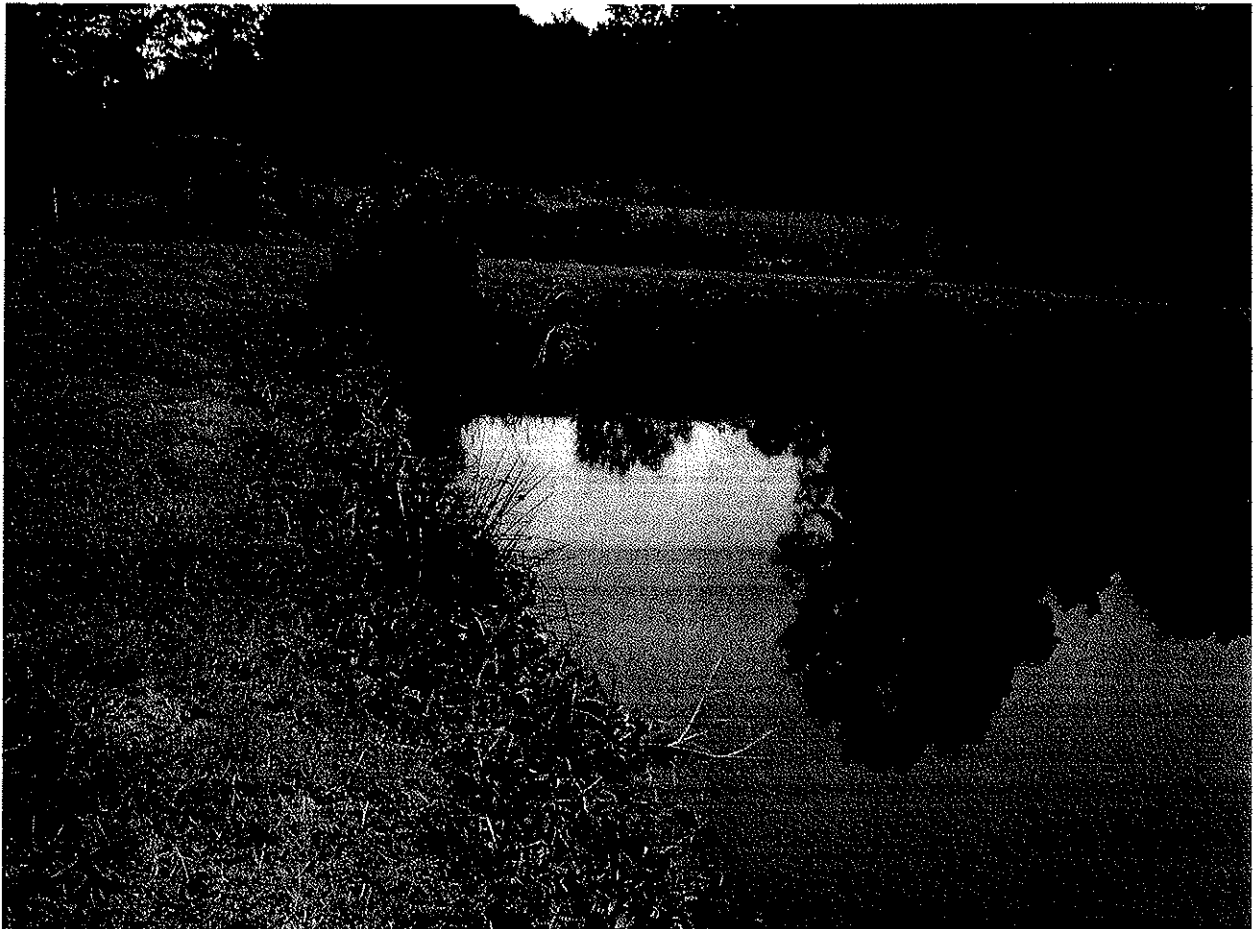
Photo: 7 of 12

Subject: Failed to remove overgrown vegetation from the pond banks

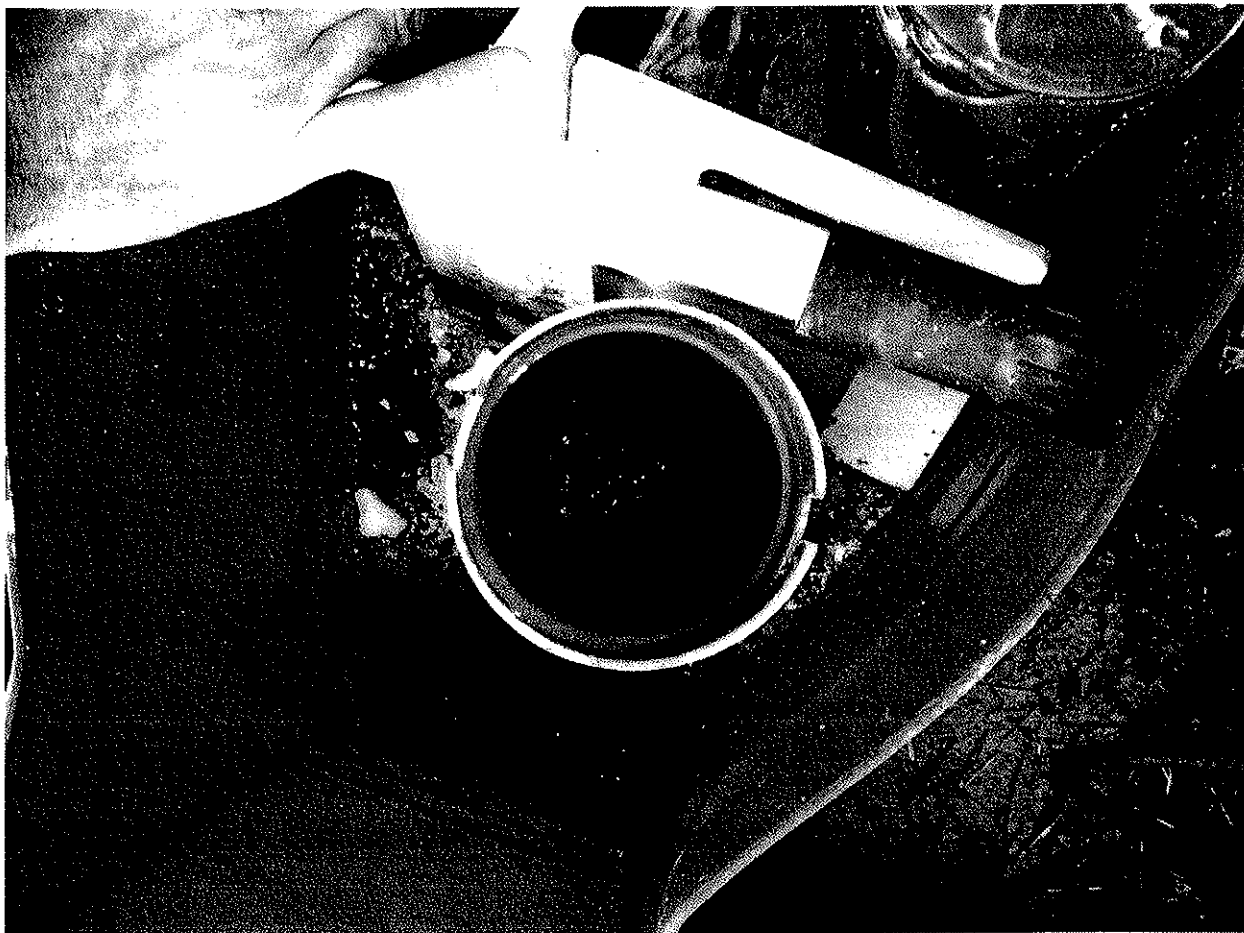
Photo: 9 of 12

Subject: No chlorine in tube

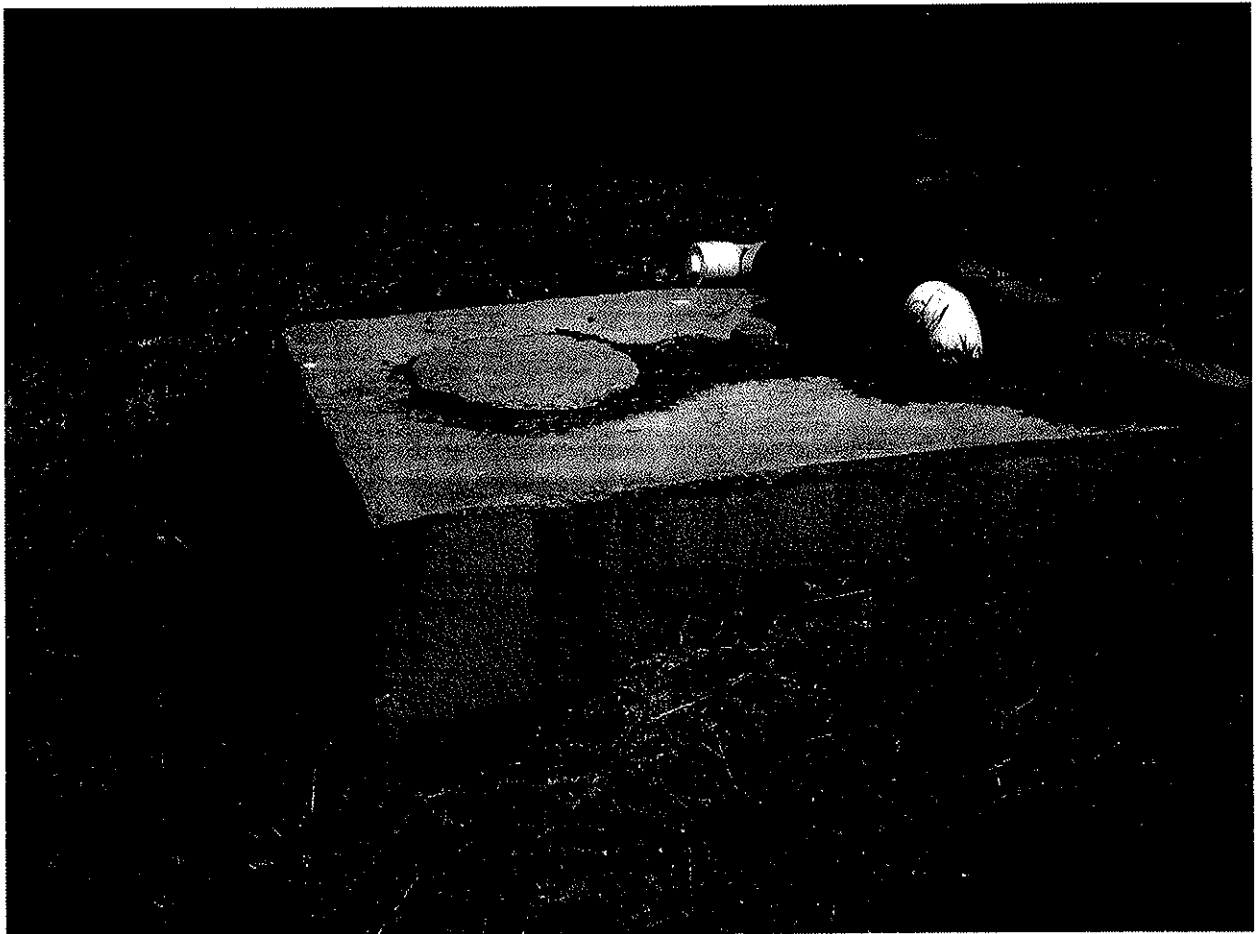
Photo: 2 of 15

- The WWTF flow by passed the treatment and discharged under the outfall pipe.
- Chlorine chamber had flow, but the flow did not match the discharge.
- Failed to secure the perimeter of the pond.
- One aerator was working, however the aerator was placed in a poor location.
- Chlorine was not observed in the contact chamber.

Subject: Effluent escaping the sides of the discharge location

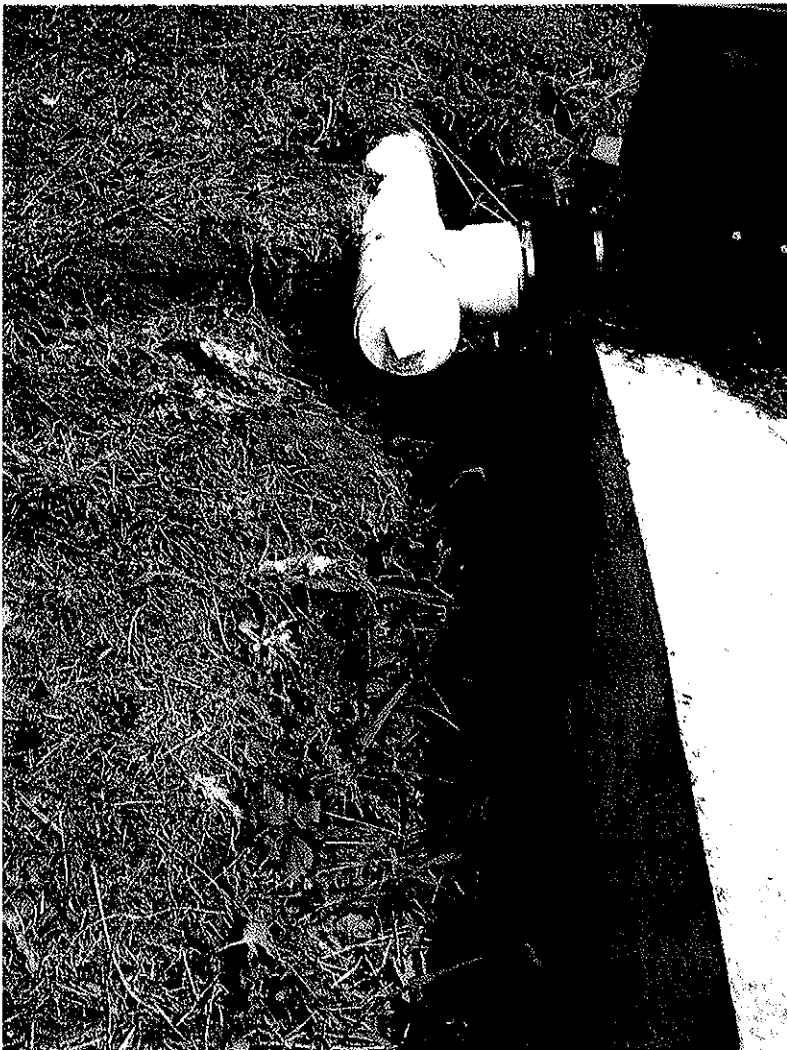
Photo: 3 of 15

Subject: Effluent escaping the sides of the discharge location

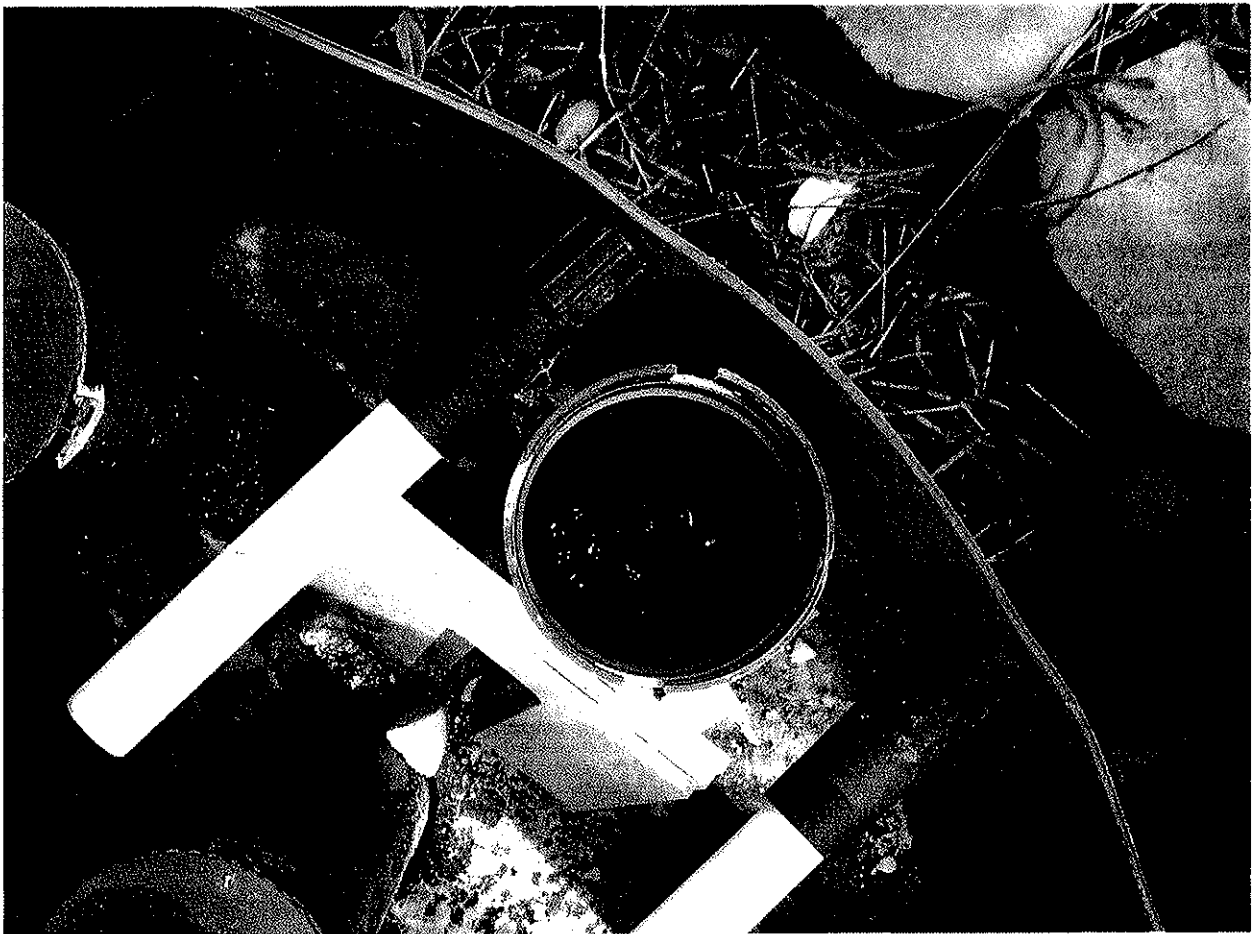
Photo: 4 of 15

Subject: No chlorine in tube

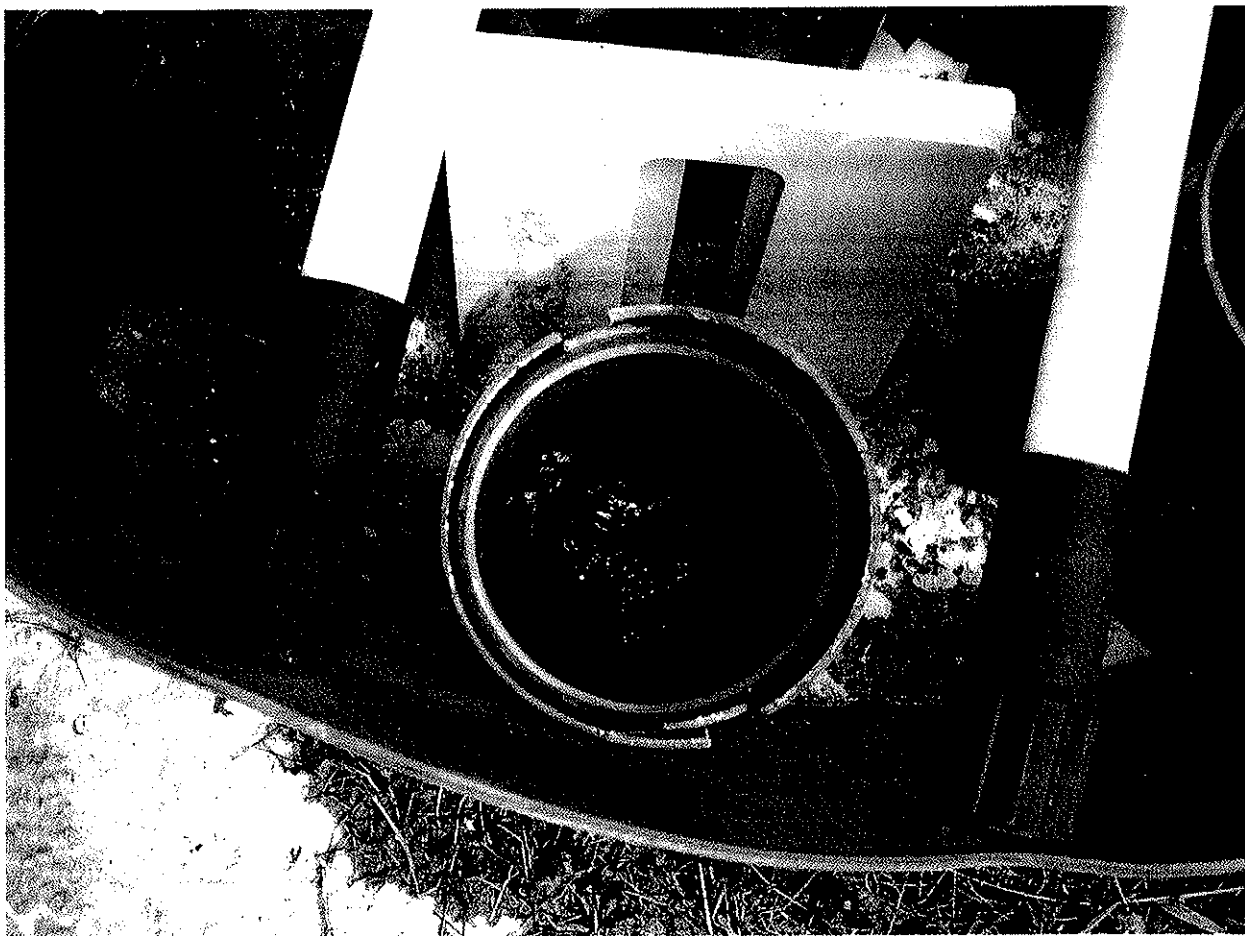
Photo: 5 of 15

Subject: No chlorine in tube

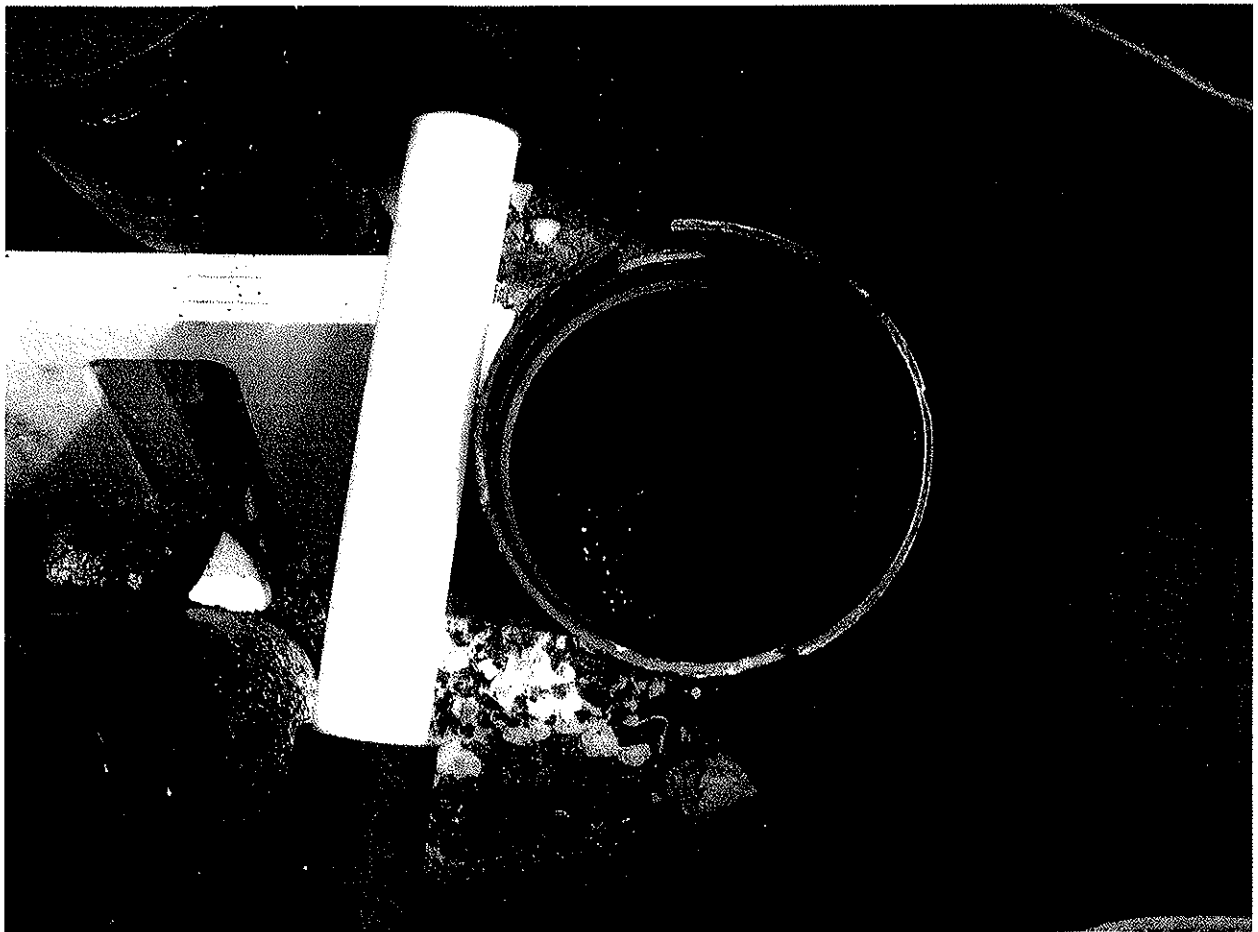
Photo: 6 of 15

Subject: No chlorine in tube

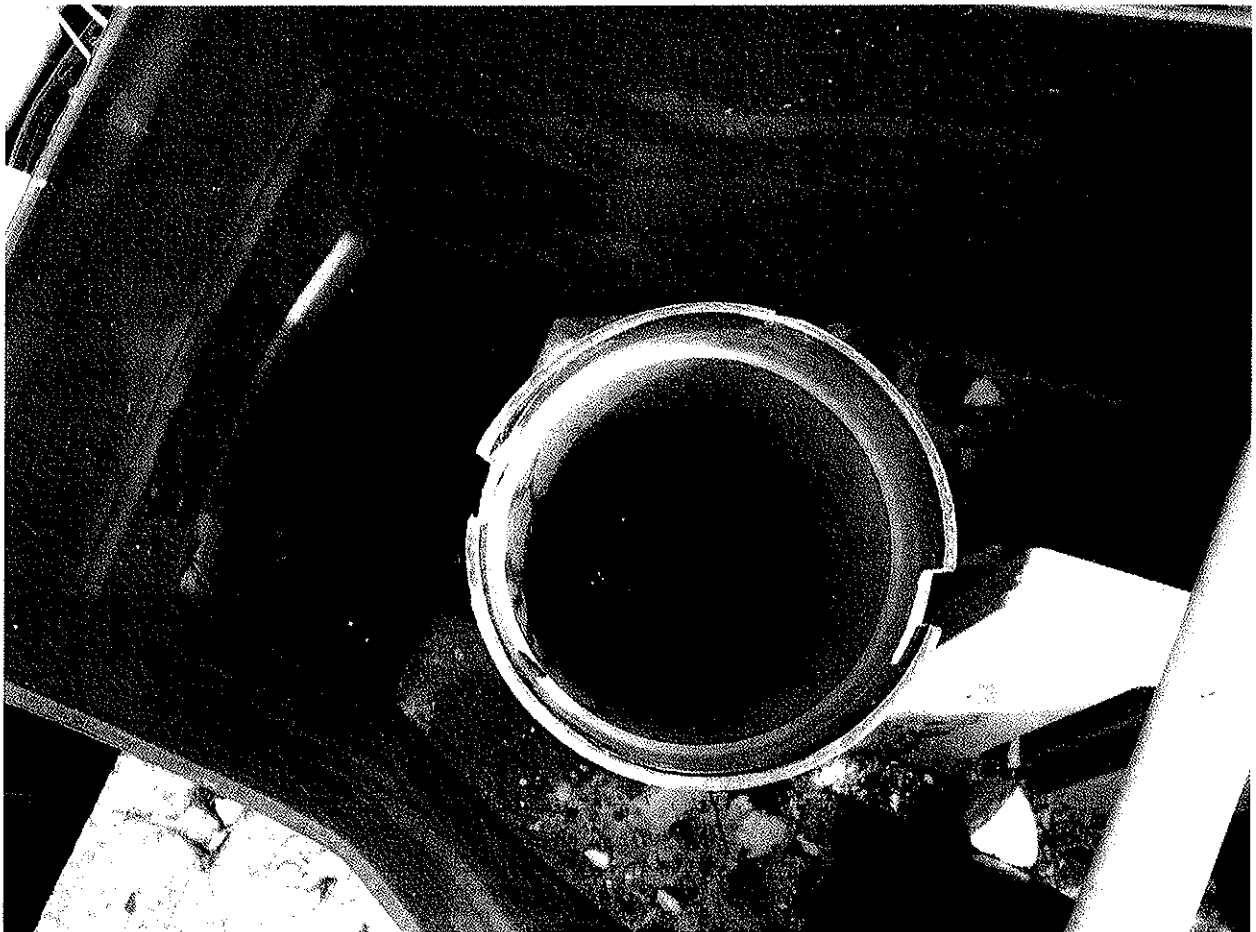
Photo: 7 of 15

Subject: No chlorine in tube

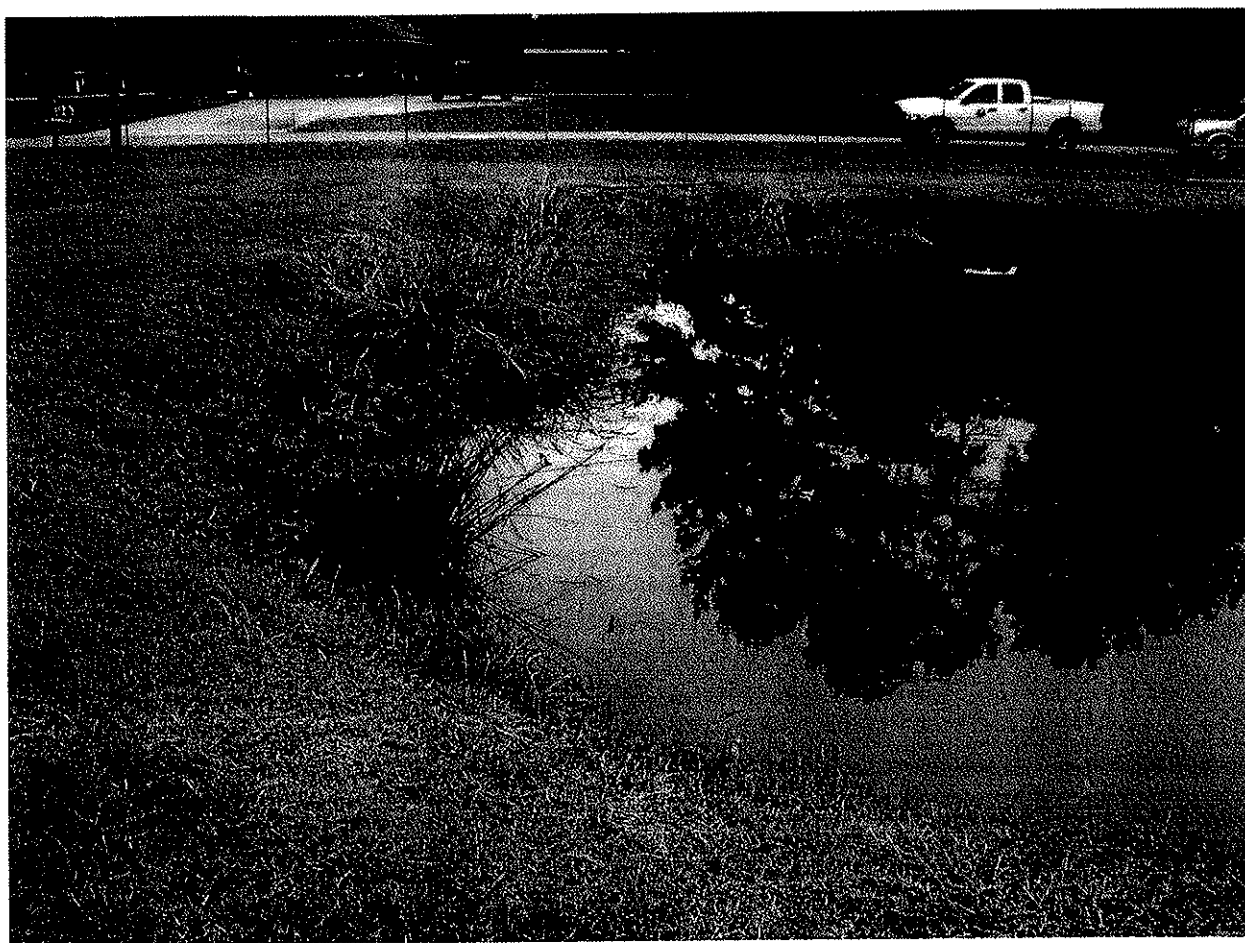
Photo: 8 of 15

Subject: Failed to prevent overgrown vegetation on the pond banks

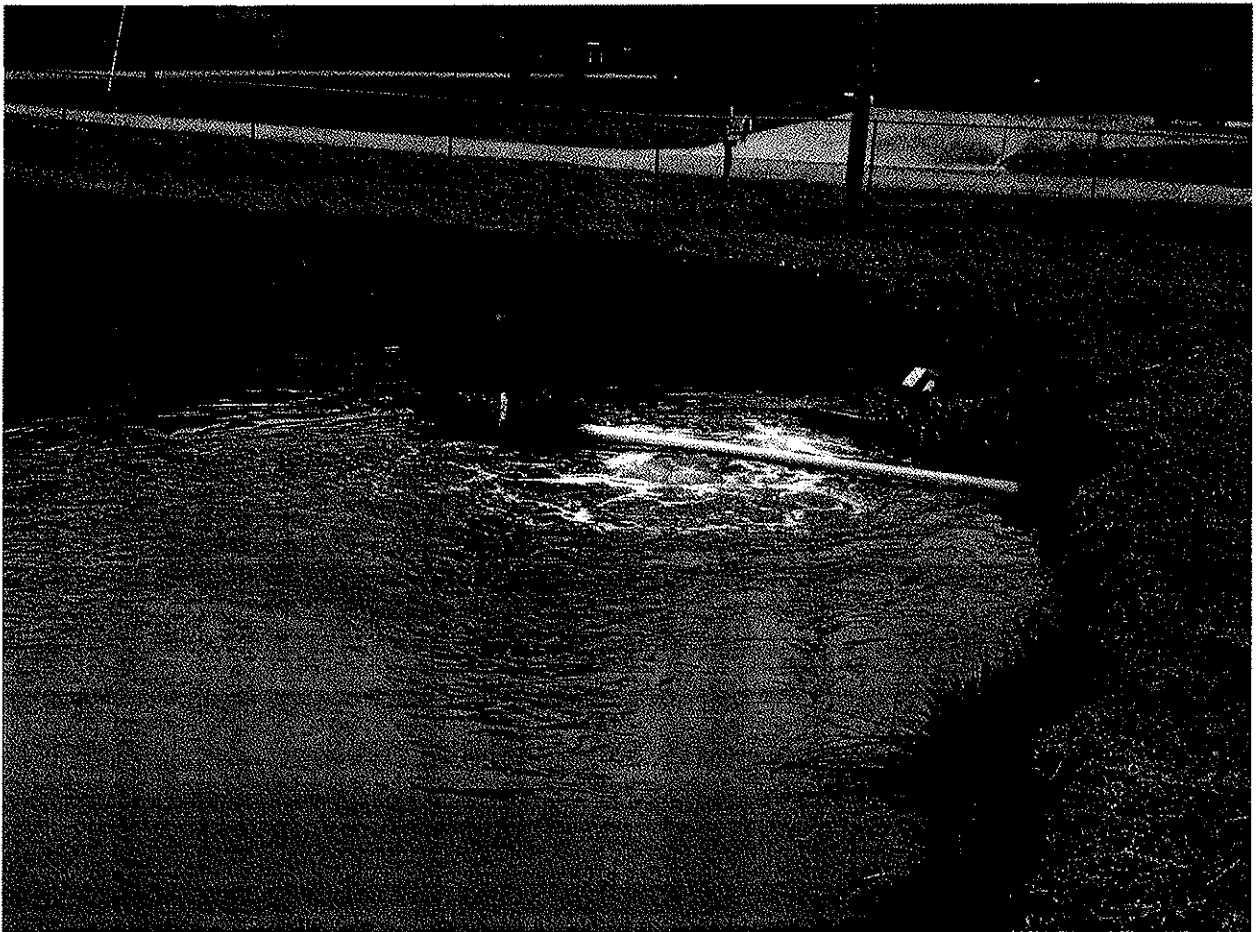
Photo: 9 of 15

Subject: Failed to place aerator in the proper location

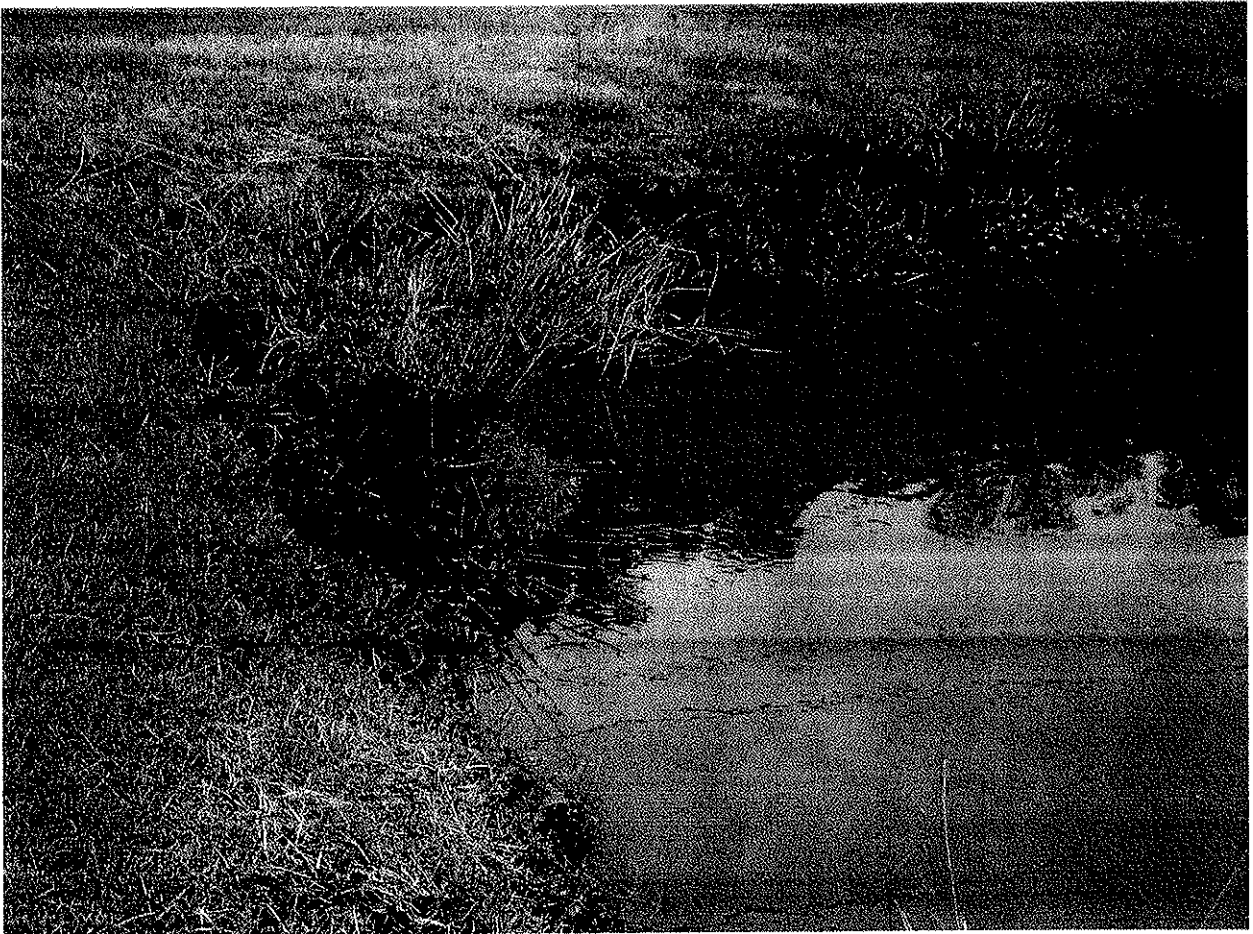
Photo: 10 of 15

Subject: Failed to prevent overgrown vegetation on the pond banks

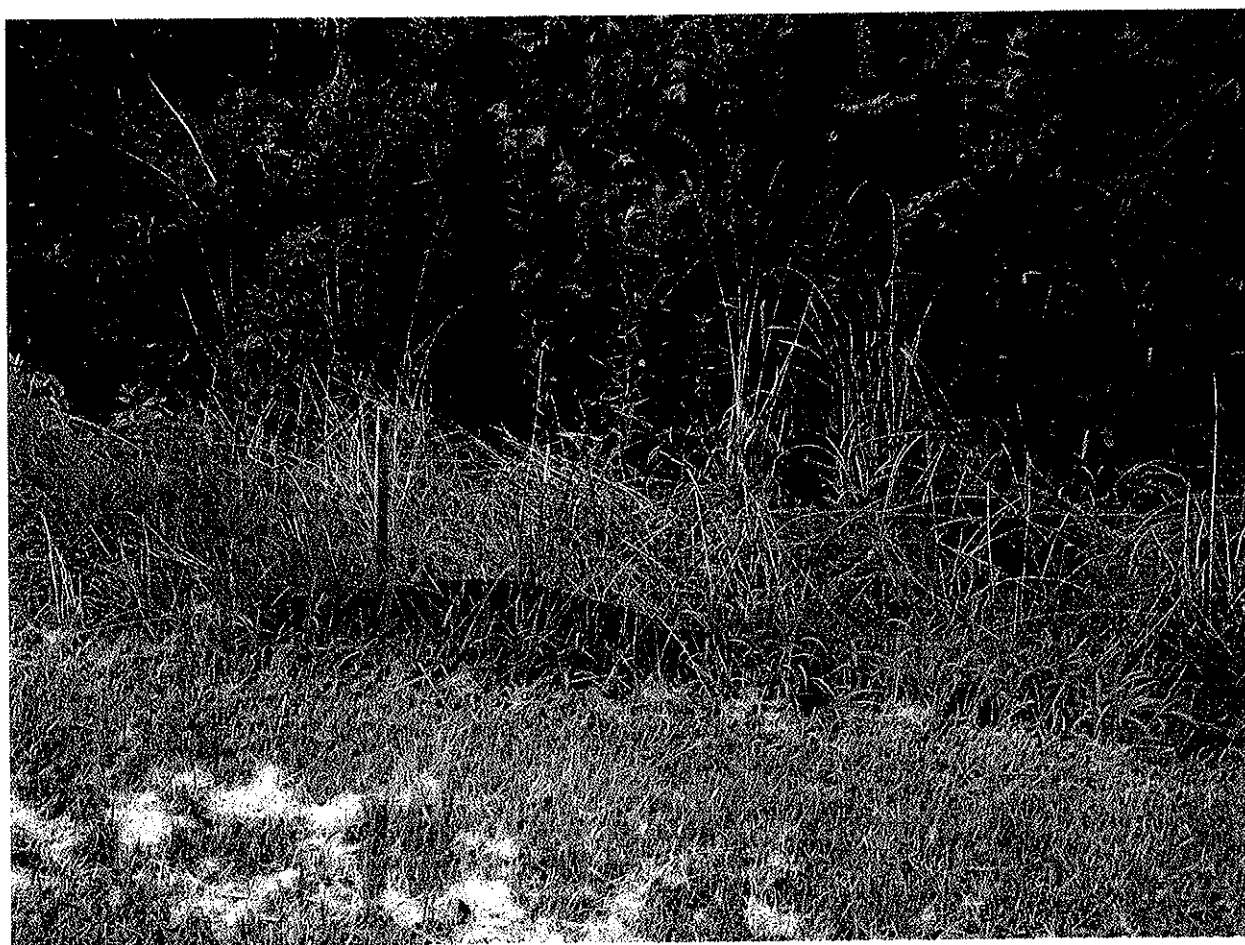
Photo: 12 of 15

Subject: Failed to secure the perimeter of the treatment facility

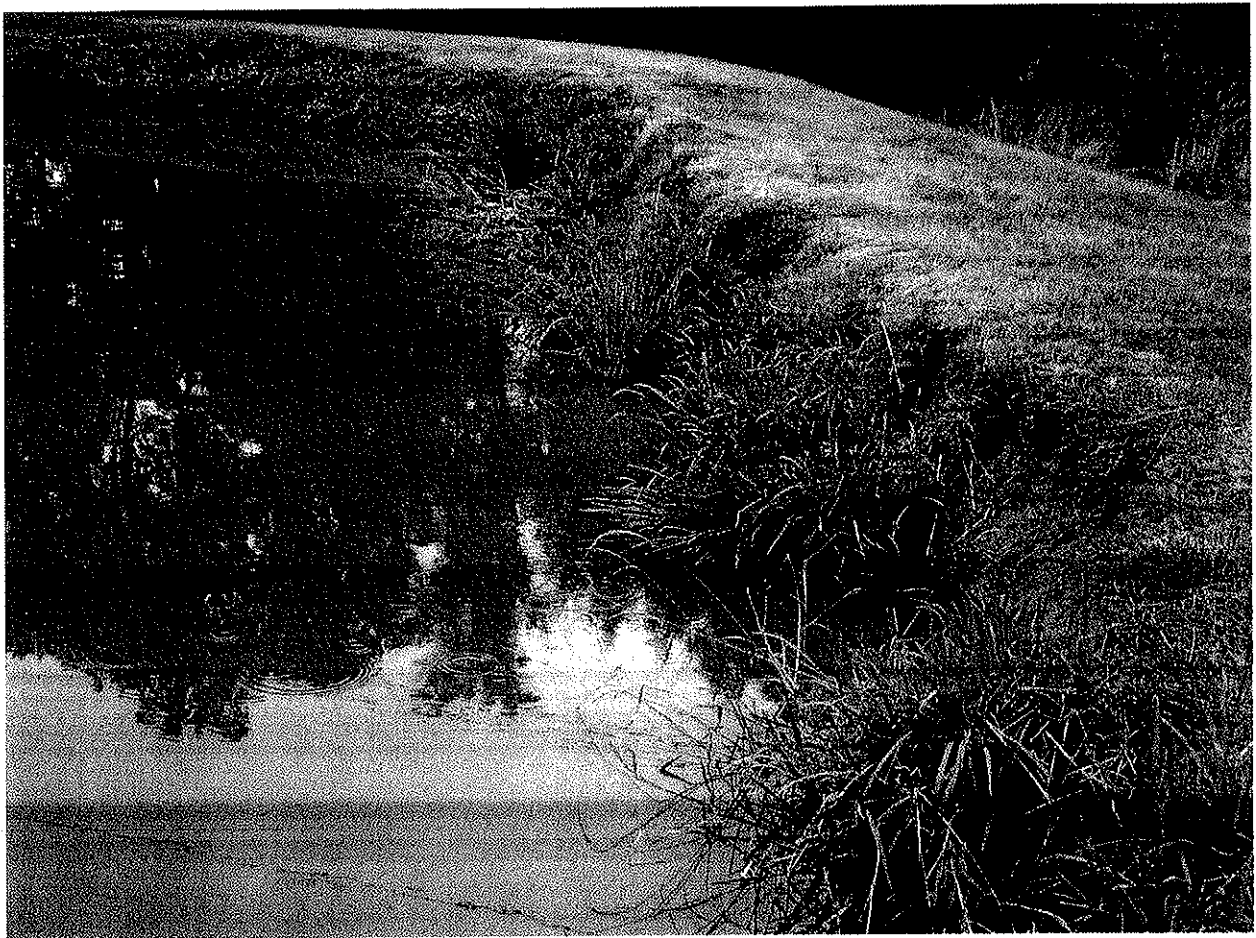
Photo: 14 of 15

Subject: Failed to prevent overgrown vegetation on the pond banks

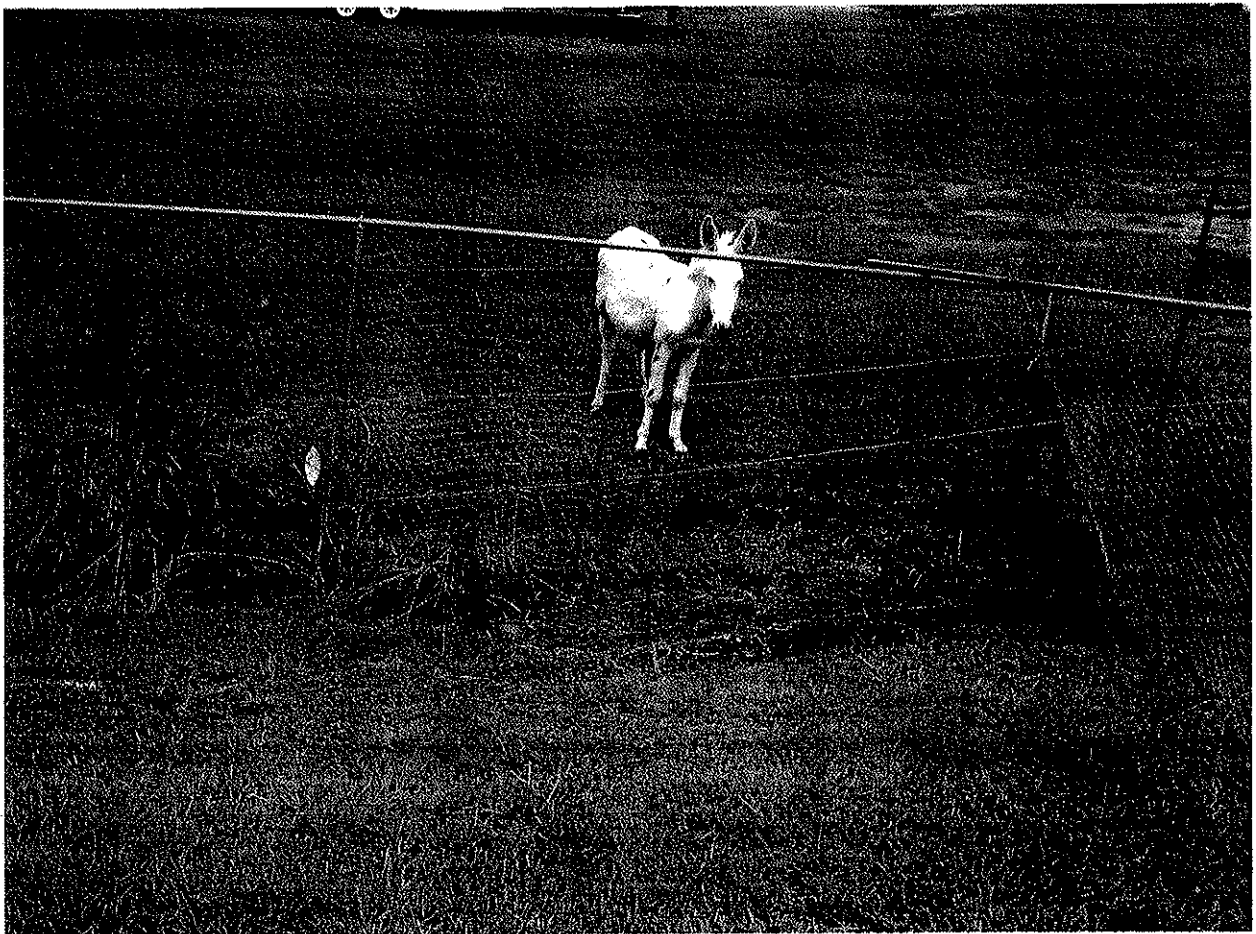
Photo: 15 of 15

Subject: Failed to secure the perimeter of the treatment facility

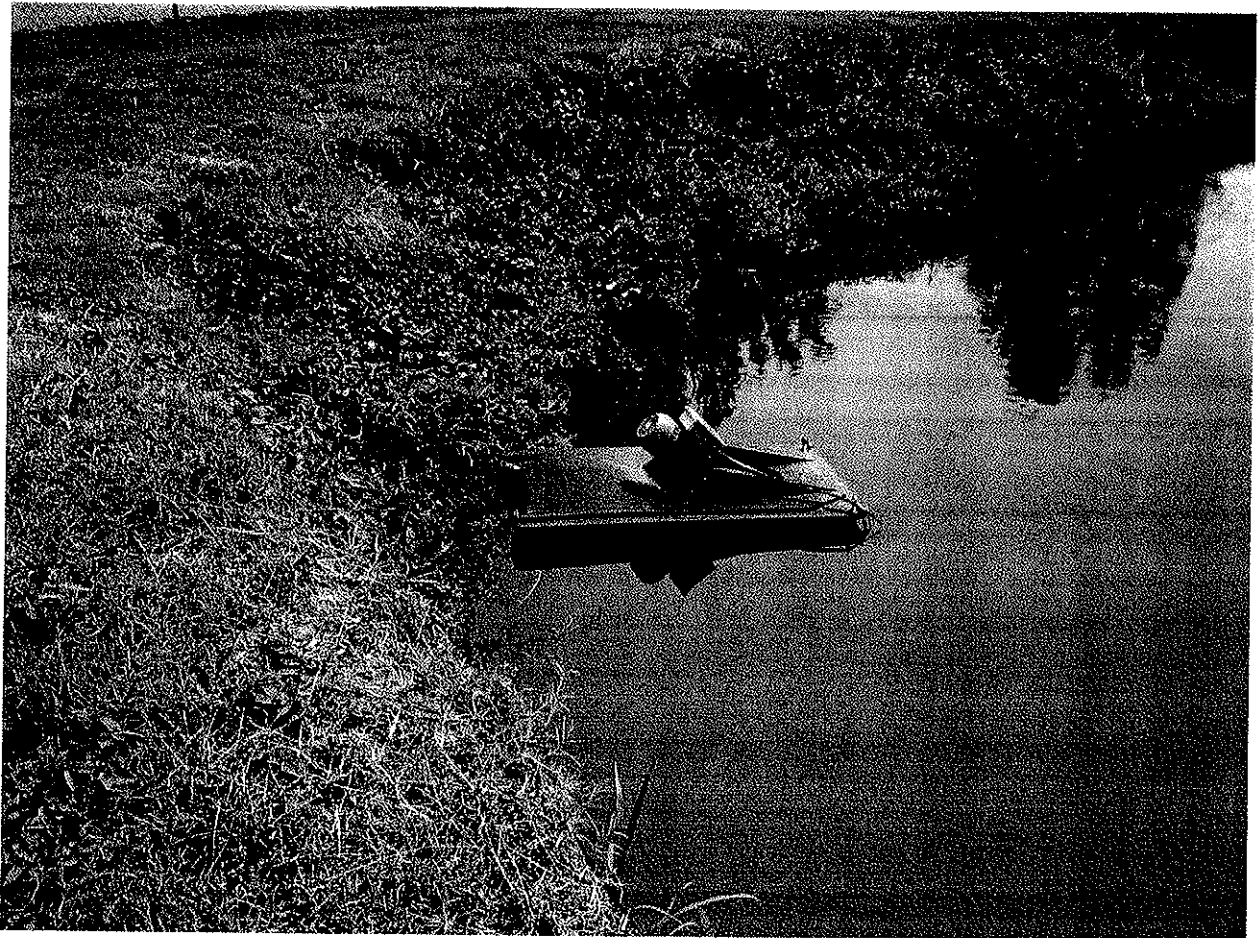
Subject: Failed aerator

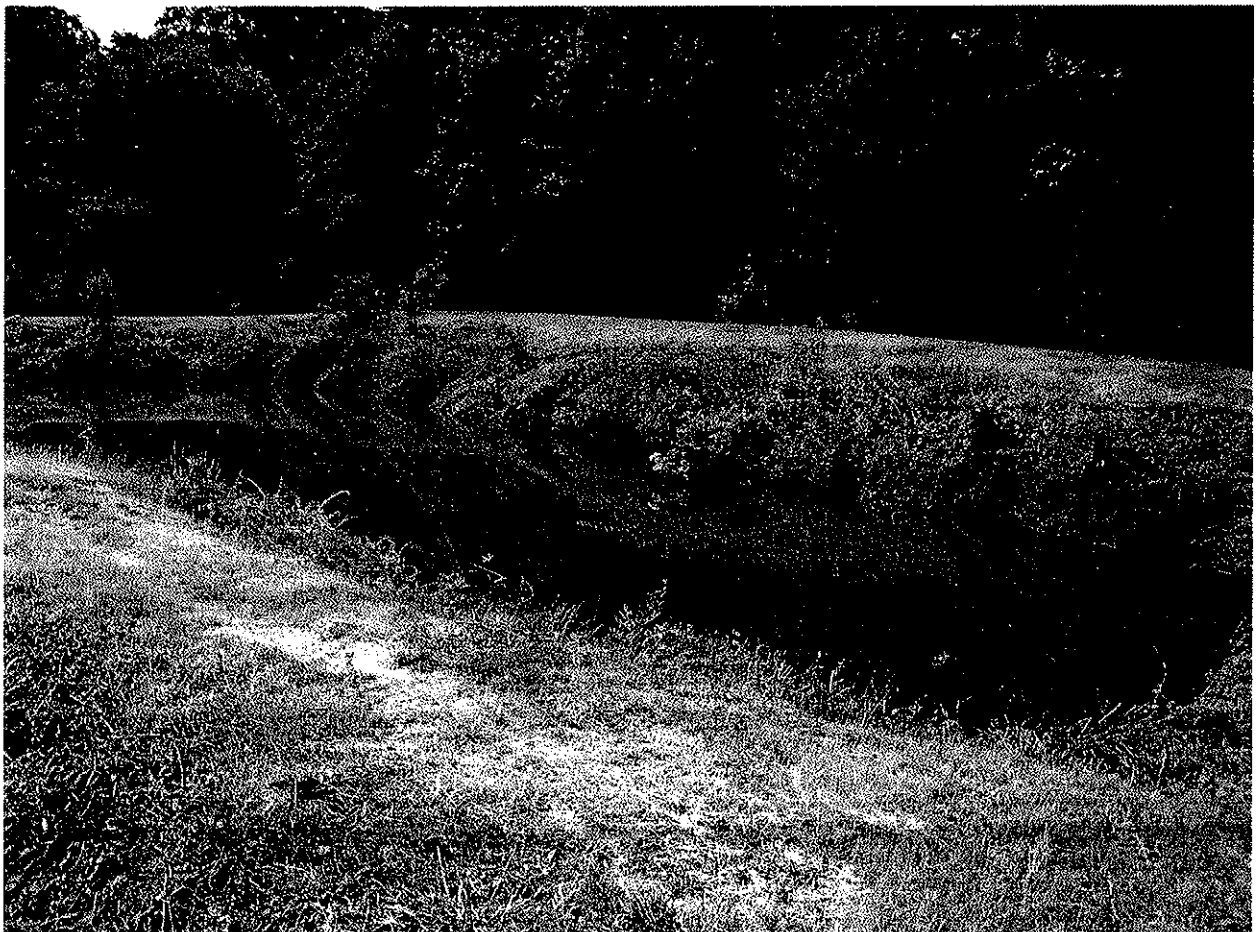
Subject: Failed to prevent overgrown vegetation on the pond banks

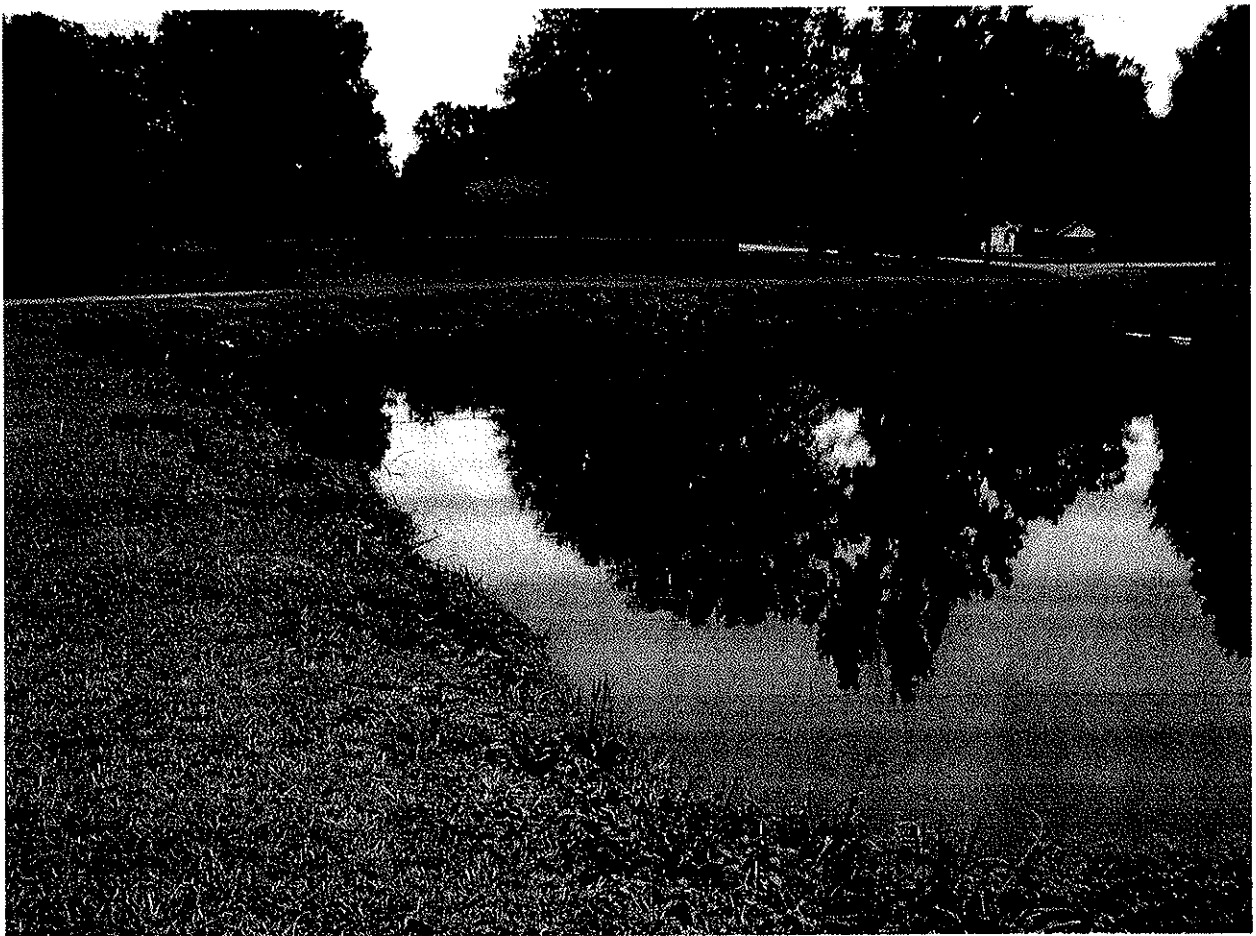
Subject: Failed aerator

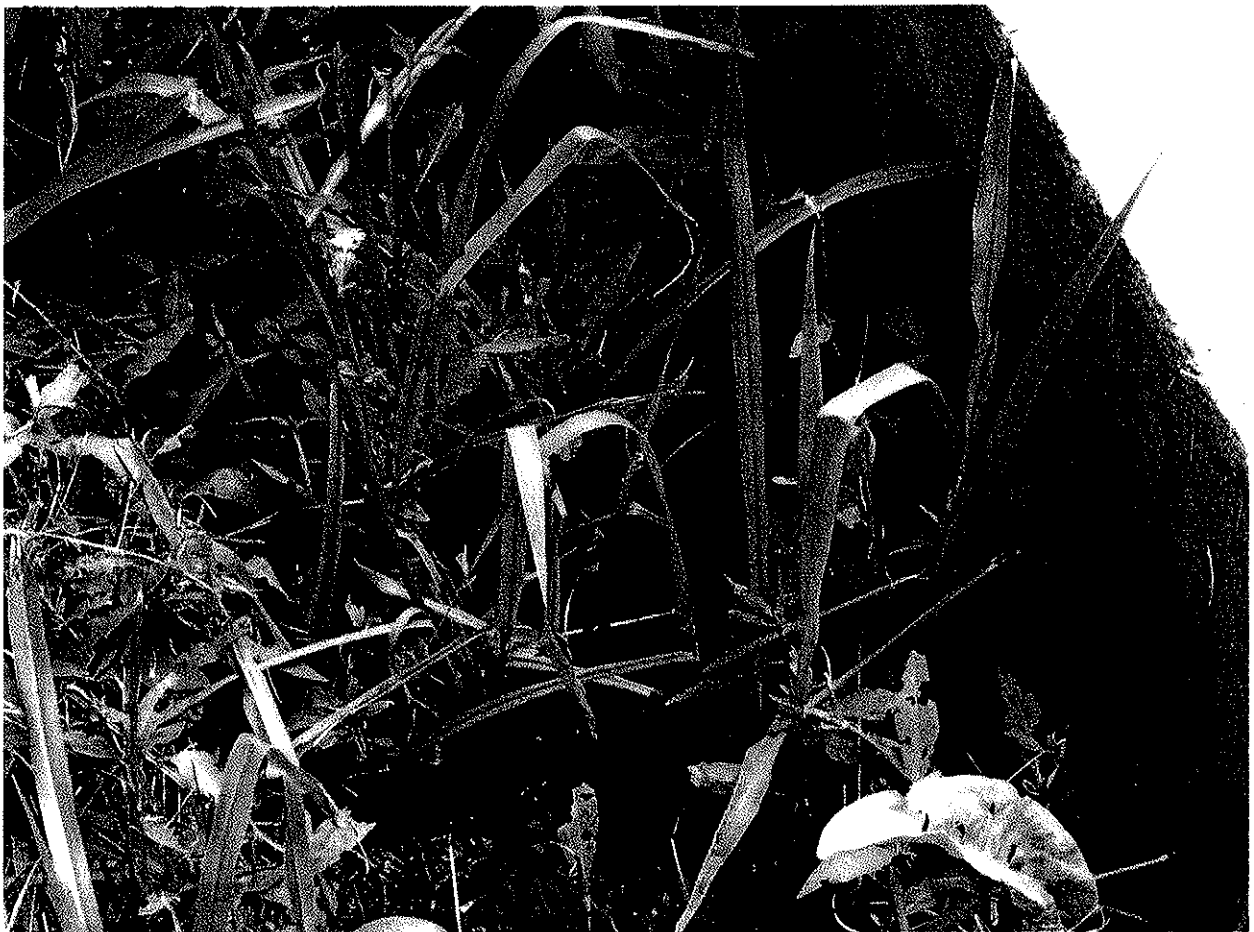
Subject: Effluent escaping the chlorine contact chamber

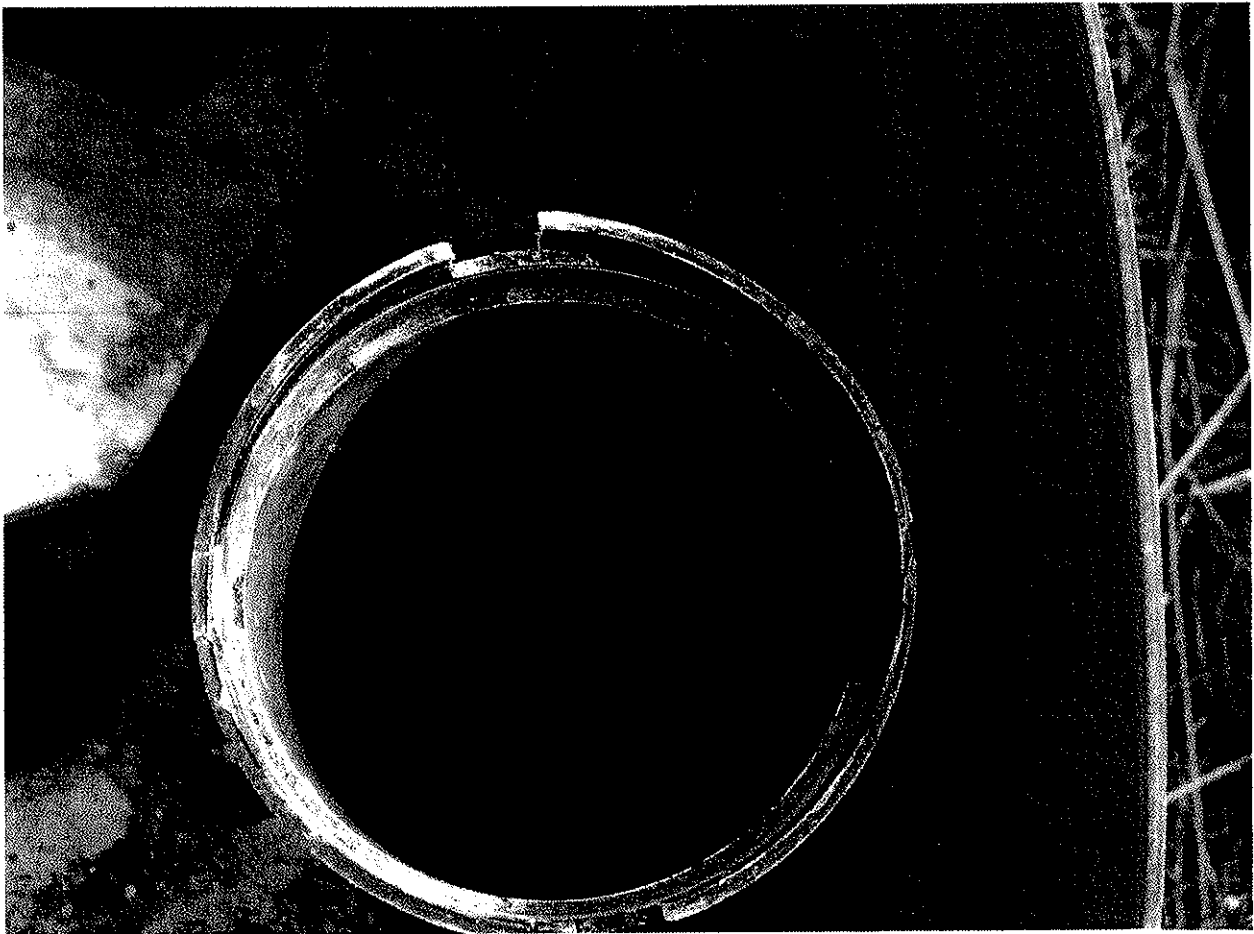
Subject: No chlorine in tube
